UNDERWATER INSPECTION
AND RECOMMENDATIONS FOR THE
BRIGHTON DAM ACOUSTIC FACILITY
Naval Surface Weapons Center
Brighton, Maryland

FPO-1-84 (40)
March 1985

William N. Seelig, P.E.
and
James Hansen

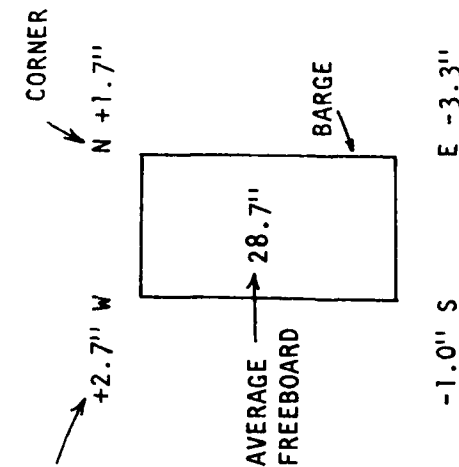
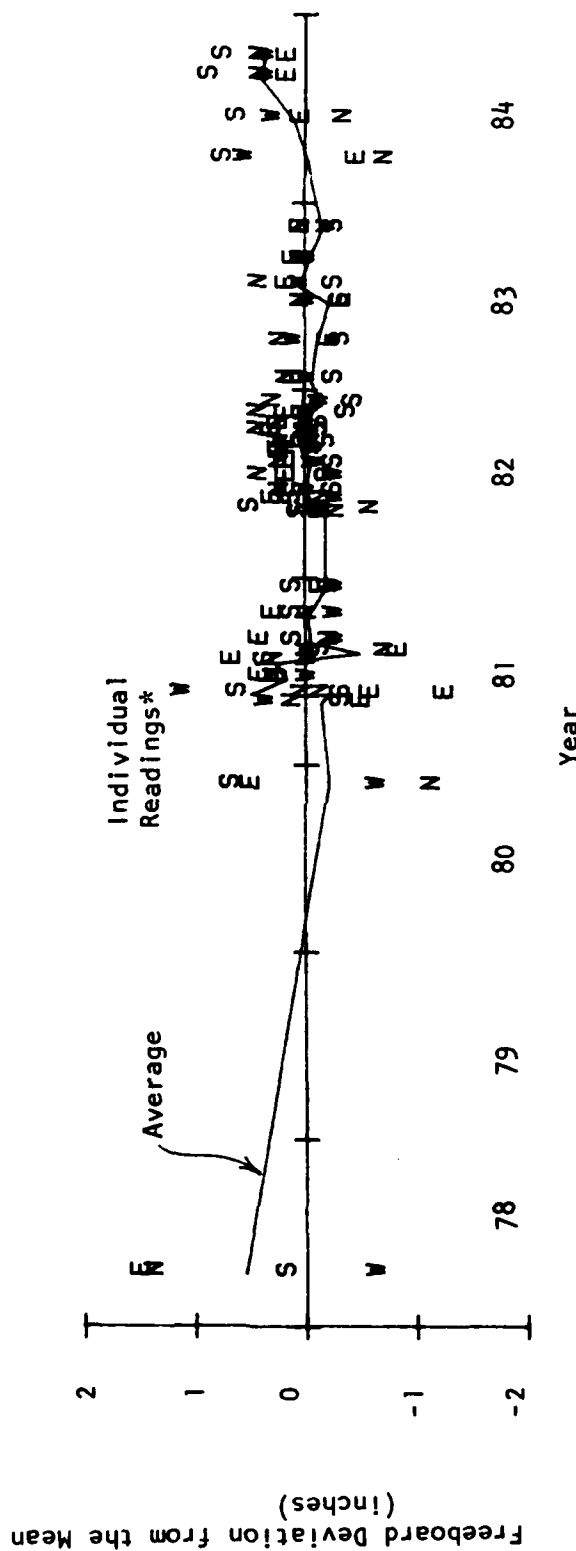
Figure 3. Barge Freeboard Measurements 1978 thru 1984

One of the most important questions to ask about a floating vessel is "Is it sinking?". NSWC wisely has been measuring the barge freeboard of the Brighton Dam facility from 1978 to the present. These measurements show that the barge is not sinking and that the average freeboard has not varied more than 1/2 inch from the mean value of 28.7 inches for the past seven years (Figure 3). In fact, the freeboard increased during the latter portion of 1984 (Figure 3). The increase in freeboard is a direct result of removing heavy electronic gear from the barge and installing lightweight equipment in early 1984 (W. Phelps, personal communication, 5 November 1984).

These measurements also show that the barge is slightly listing with greater freeboard to the west and north corners (see Figure 3, upper right). The freeboard of the west corner of the barge is 2.7 inches above the average barge freeboard and the east corner is 3.3 inches below average. Listing of the barge is due to the combined effects of: (1) the weight distribution and (2) pontoons on the east corner of the barge were not completely filled with foam (W. Phelps, personal communication, 5 November 1984). This slight listing is not important.

As an absolute minimum NSWC should make: (1) monthly barge freeboard measurements and (2) a swim-by underwater inspection every three years.

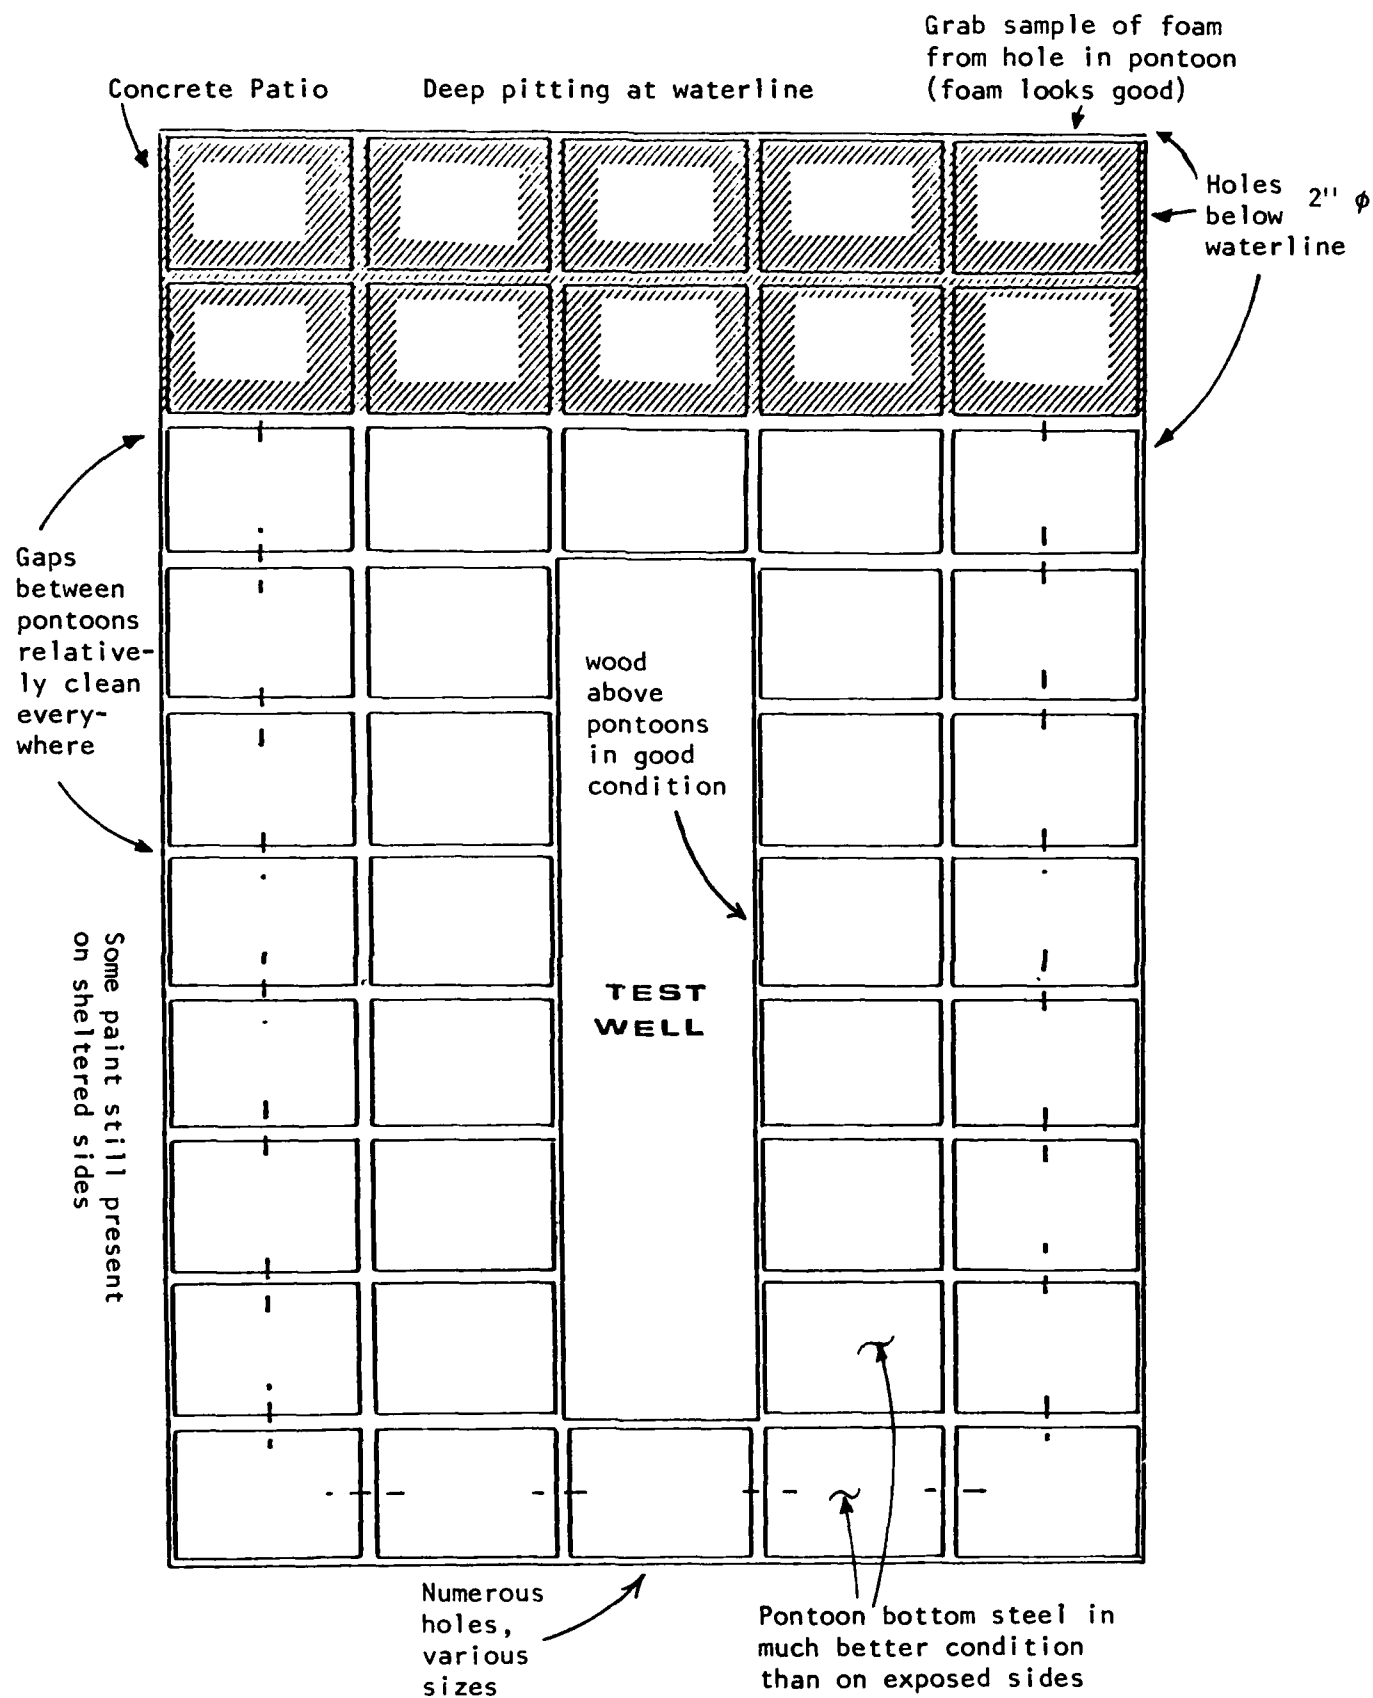
Figure 5. Underwater Inspection Notes

3. Corrosion occurs from the waterline to one-foot below the waterline on the faces of the pontoons (see Figure 5). A number of holes are present in pontoons A-5, C-5 and K-3. The combined action of small waves and/or ice motion is probably responsible for the corrosion and damage near the waterline.

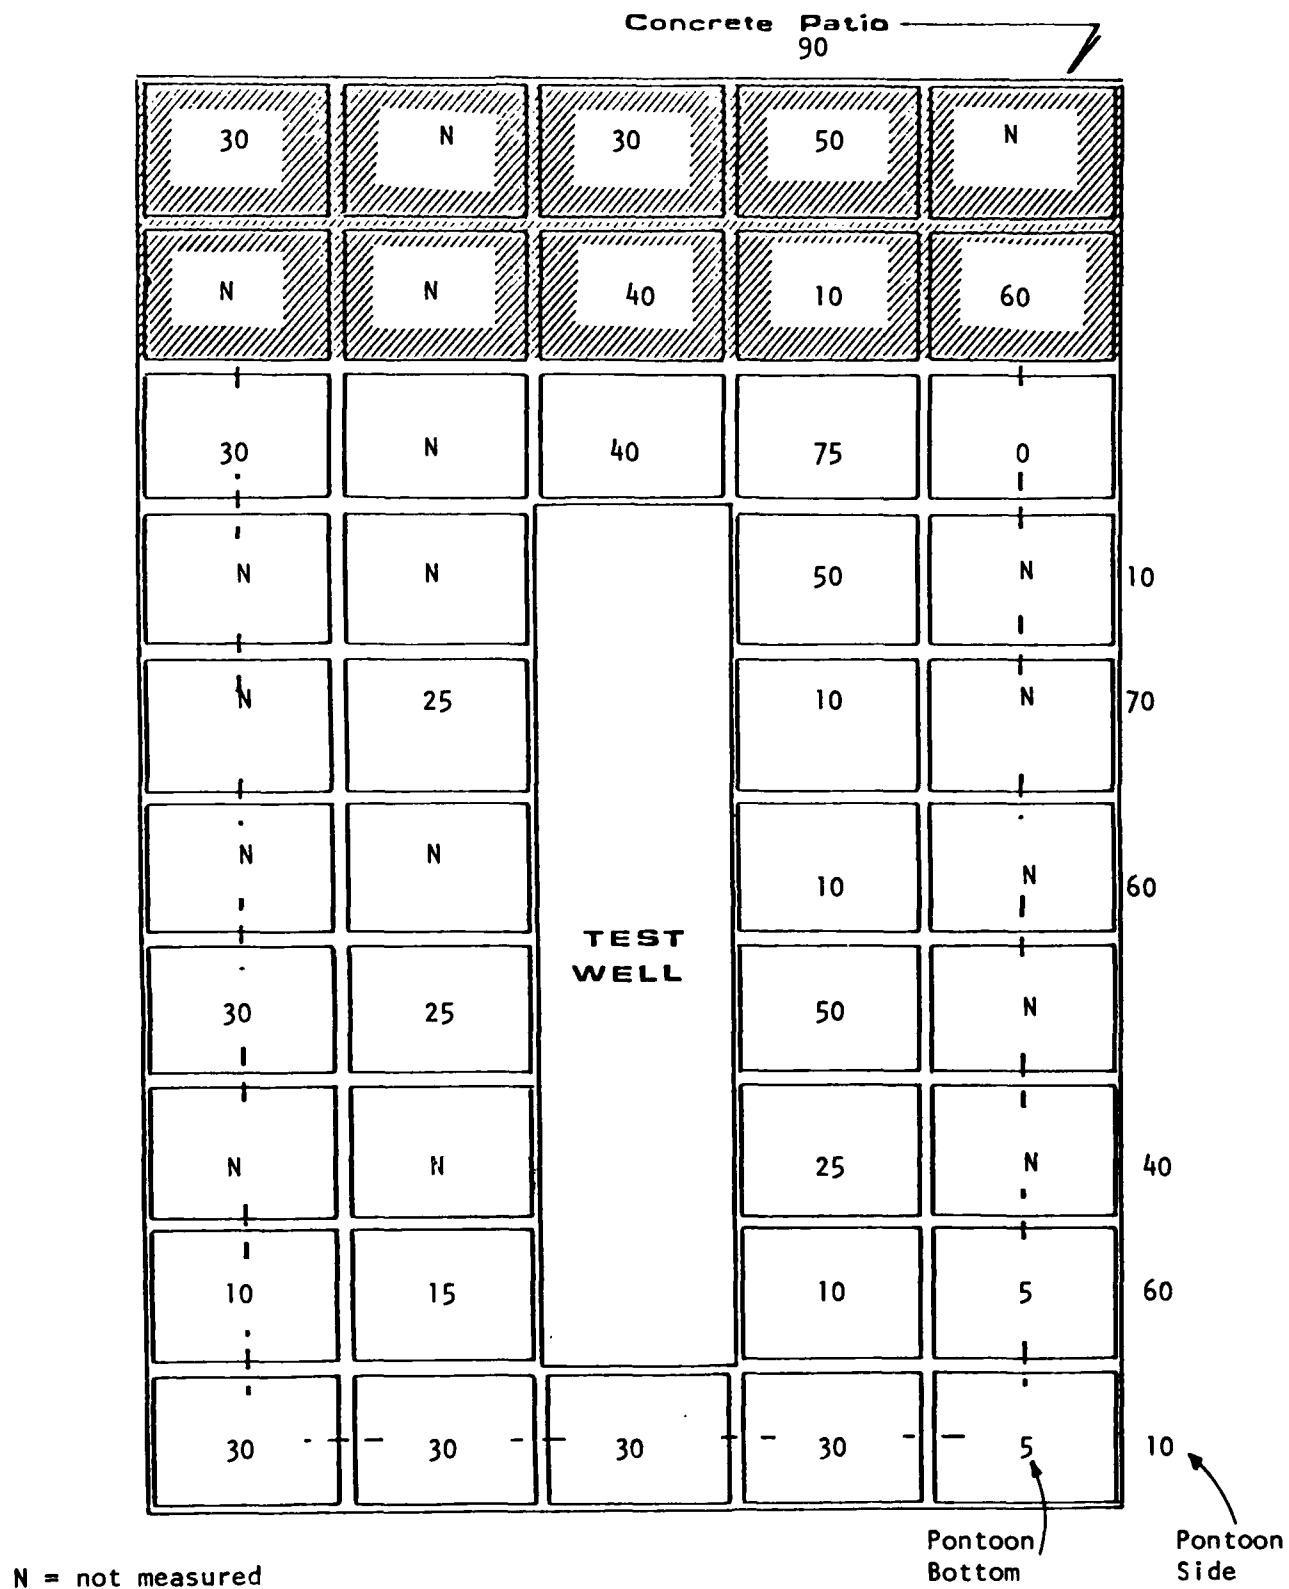
Figure 6. Percent of Cleaned Area That has Pitting

4. Pitting type corrosion controls elsewhere (Figure 6). The amount of pitting varies from one pontoon to the next and from one spot on a pontoon to another. These "hot spots" of corrosion may be in part due to imperfections in the metal and break down in the coating system.
